**NASA TECHNICAL
MEMORANDUM**

NASA TM X-53808

**EFFECTS OF WELD HEAT ON THE PROTECTIVE PROPERTIES
OF CONVERSION COATINGS**

By R. H. Higgins
Propulsion and Vehicle Engineering Laboratory

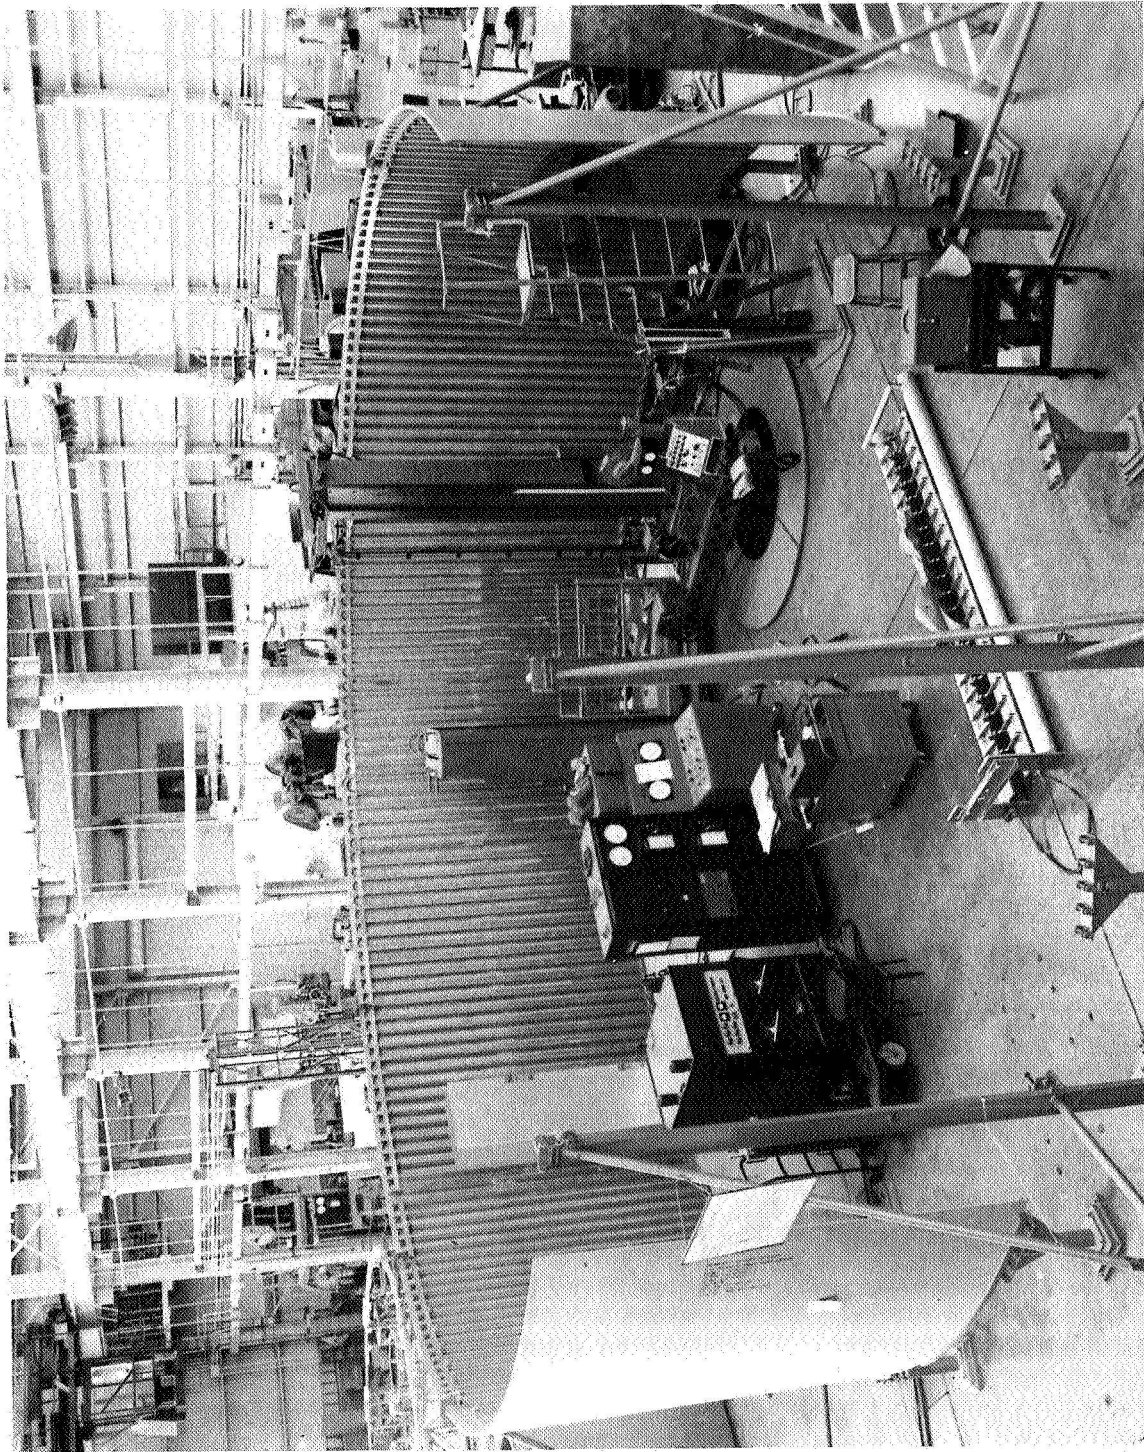
FIGURE 1 - Assembly of Saturn S-IC Tank Skin

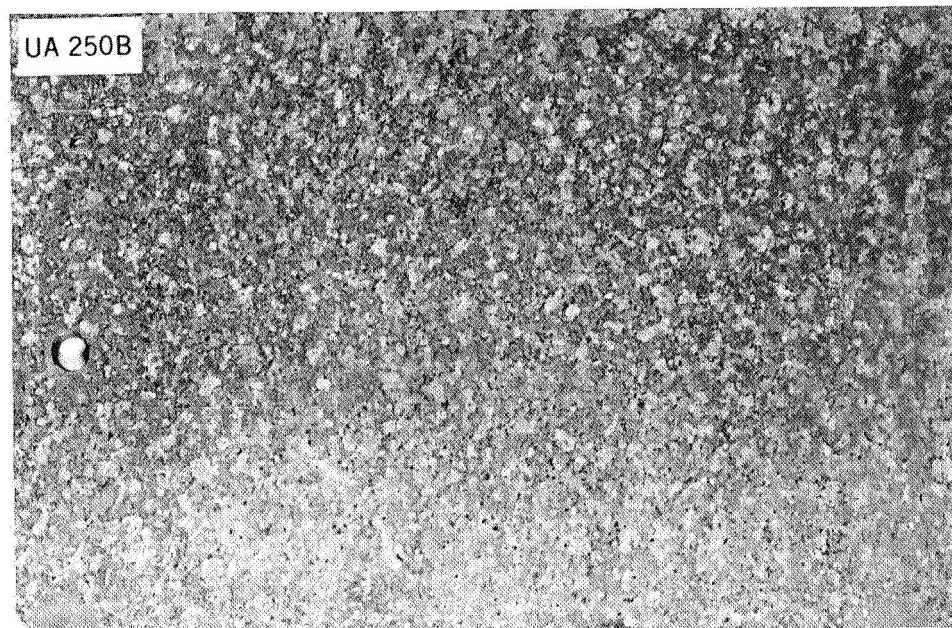
FIGURE 5 - Conversion Coated Panels Exposed to 180°F, (Above) and 200°F (below) 24 Hours Salt Spray

Results obtained in salt spray tests of the 0.5 inch welded material indicated that data were needed to ascertain the degree of coating degradation that could be expected after exposure to specific temperatures for short periods of time. Since this type of information could be obtained with laboratory controlled tests, duplicate panels 4 inches by 6 inches by 0.100 inch were coated, subjected to a heat treatment and exposed to the salt spray. In these tests, regardless of coating, heat exposure time or aging, all panels subjected to temperatures of 180°F (82°C) or greater had light corrosion over the surface after exposure to the salt spray for 24 hours (FIG 5). The corrosion increased rapidly with additional exposure time. Panels subjected to a temperature of 160°F (71°C) were somewhat less affected, and the corrosion did not progress as rapidly as panels exposed to higher temperatures. Panels exposed to a temperature of 140°F (60°C) were only slightly affected (FIG 6), and additional exposure to the salt spray did not result in a substantial increase of corrosion (FIG 7). The Iridite 14-2 coatings appeared to have a slight advantage over the Alodine 1200 coatings at a temperature of 140°F (60°C); however, both coatings provided protection similar to coatings which had not been subjected to the heat treatment. The coatings did not appear to be affected appreciably by exposures to 120°F (49°C) (FIG 8) which was further demonstrated when the salt spray exposure was extended to 168 hours (FIG 9). No appreciable difference was noted on the unaged and aged panels, and exposure to the heat treatment for 15 minutes was almost as detrimental as a 30-minute heating. Long periods of exposure (2 hours) at a temperature of 150°F (66°C) proved almost as serious as short exposures at higher temperatures (FIG 10).

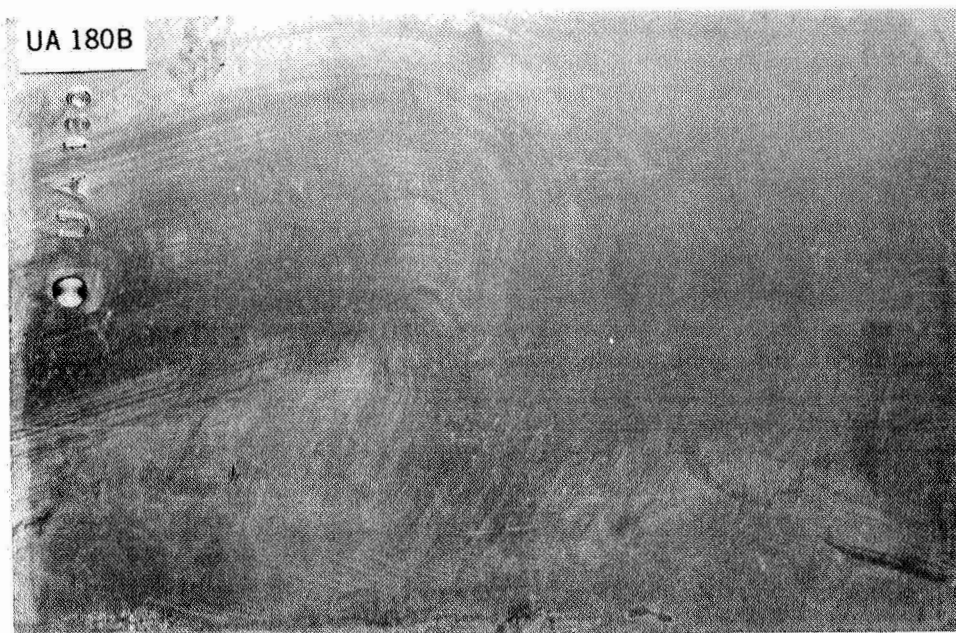
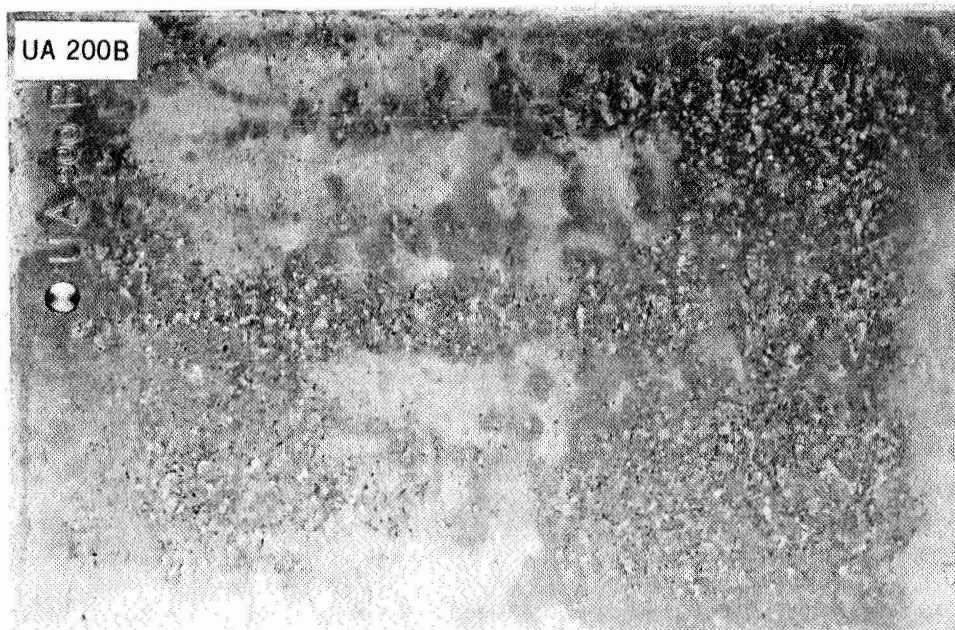
FIGURE 6 - Conversion Coated Panels Exposed to 140°F (above) and 160°F (below) 24 Hours Salt Spray

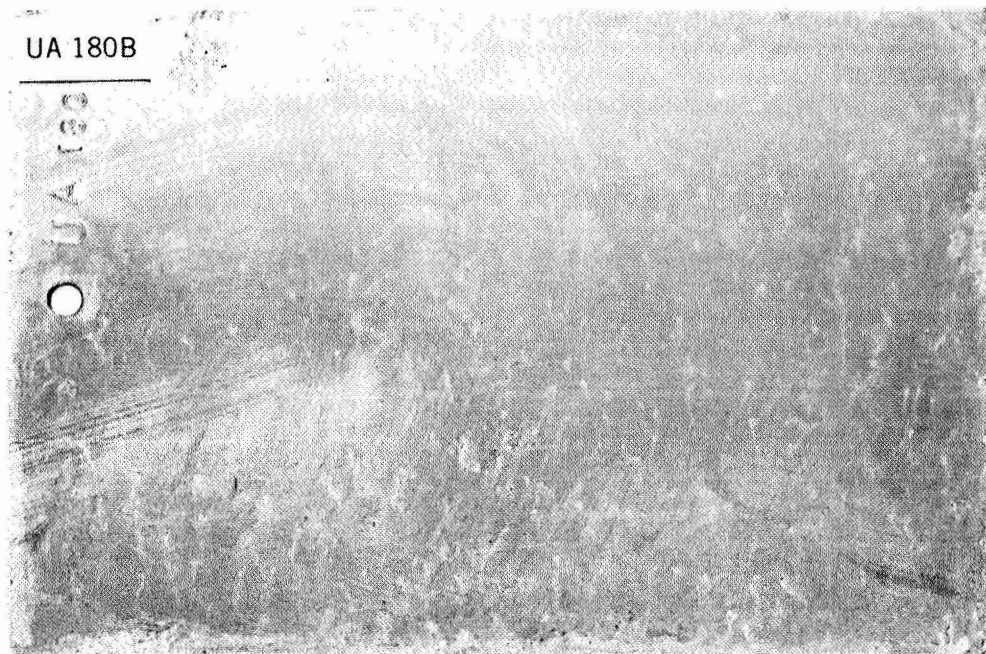
FIGURE 7 - Conversion Coated Panels Exposed to 140°F (above) and 160°F (below) 72 Hours Salt Spray

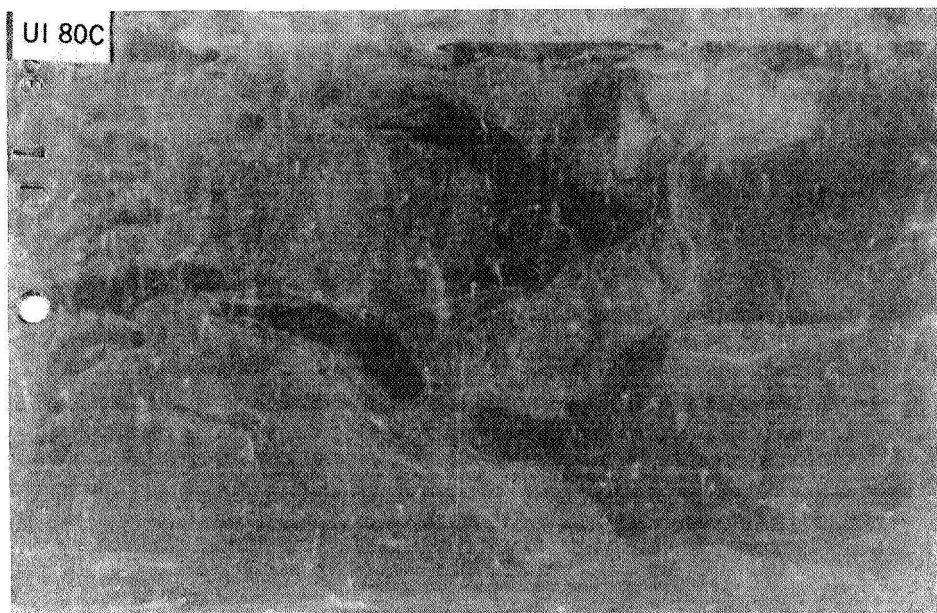
FIGURE 9 - Conversion Coated Panels Exposed to 80°F (above) and 120°F (below) 168 Hours Salt Spray
